Manhole Inspection Summary

Manhole # S21CC1004MH

Insp Date: **1/16/07 2:47 PM**

Location Address: **3614 HOOPER AVE**

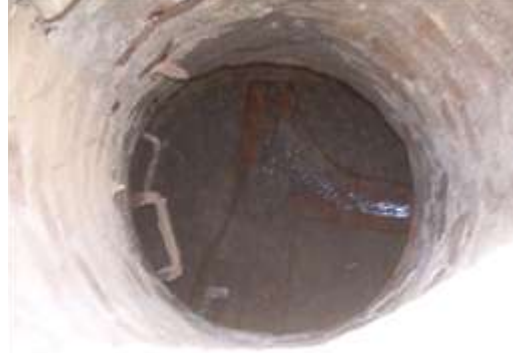
Top View

Corroded and missing steps. Evidence of surcharge - Bench debris. Channel debris.

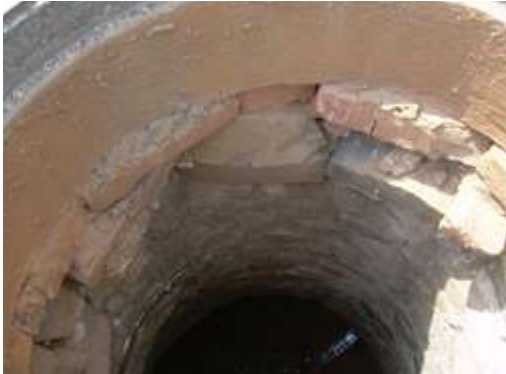
Defect

Frame leaks. Adjustment deterioration, loose brick and infiltration. Barrel infiltration - other side.

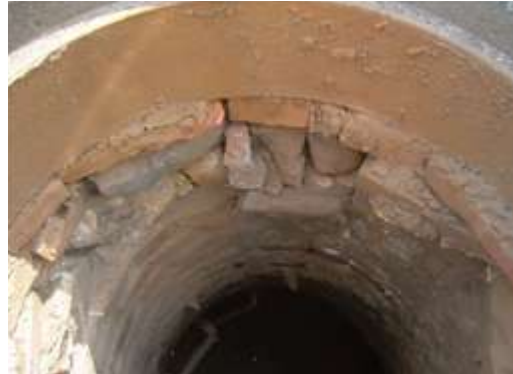
Defect

Frame leaks. Adjustment deterioration, loose brick and infiltration. Barrel infiltration.

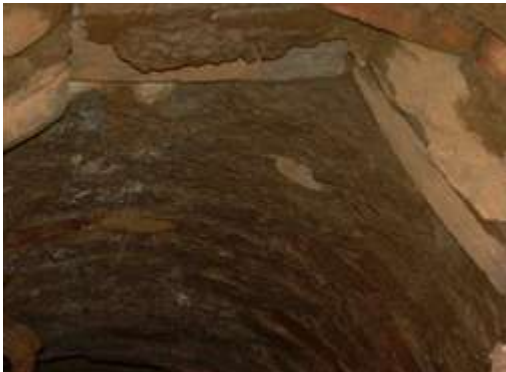
Defect

Frame leaks. Adjustment deterioration, loose brick and infiltration. Corbel infiltration.

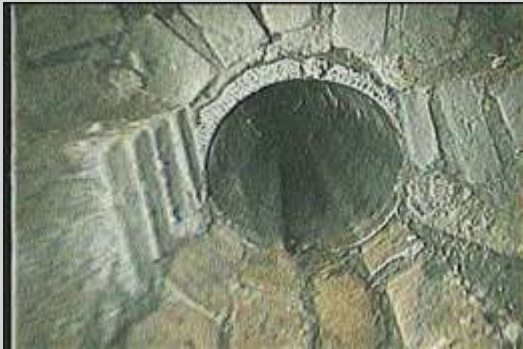
8 in. Circular Gravity Sewer Pipe Out @ 12 O'Clock

Infiltration: **Evidence** Pipe Seal Cond: **Cracked**

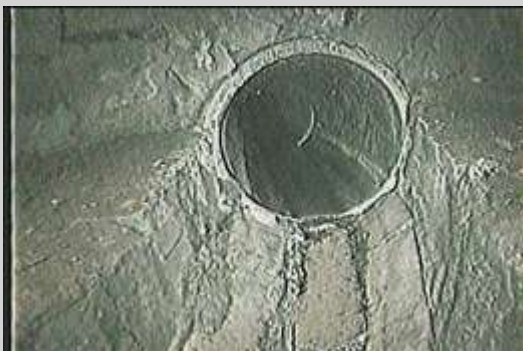
8 in. Circular Gravity Sewer Pipe In @ 3 O'Clock

Channel deterioration.

Infiltration: **Evidence** Pipe Seal Cond: **Cracked**

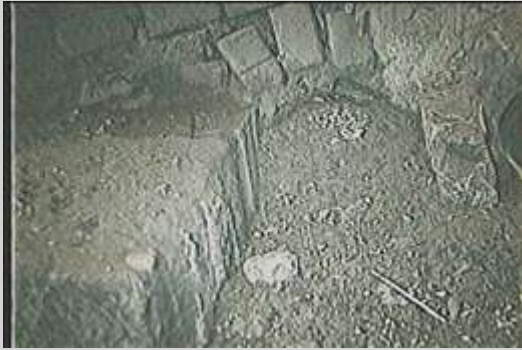
Pipe In @ 6 O'Clock

Barrel deterioration and infiltration.

Pipe Material: ☐ Pipe Lined
Invert Depth: (ft.) Flow Characteristics: **None**
Deposits: ☒ None ☐ **Mud** ☐ Sludge ☐ **Debris** ☐ Grease
Silt Depth: (in.) Deposits Extent:
Infiltration: **Evidence** Pipe Seal Cond: **Broken**

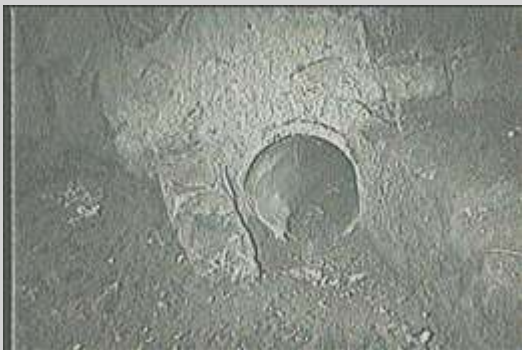
Pipe In @ 7 O'Clock

Pipe Material: ☐ Pipe Lined
Invert Depth: (ft.) Flow Characteristics: **None**
Deposits: ☐ None ☒ **Mud** ☐ Sludge ☒ **Debris** ☐ Grease
Silt Depth: **2** (in.) Deposits Extent: **Light**
Infiltration: **None** Pipe Seal Cond: **Unknown**
